Metropolitan Sewer District of Greater Cincinnati

Enabled Impact Program: Interim Summary Report – November 2013

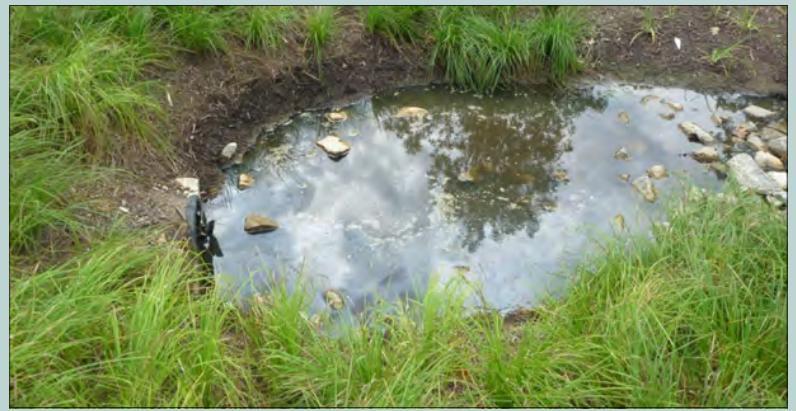
The inlets into the bioinfiltration basins were designed with low entry elevations and a clay berm surrounding the inlet to the basin to create a sediment forebay. This design did not allow stormwater to drain out of the forebay section, and the ponding has caused stagnation and mosquito breeding in this area. Bioinfilration basins, including forebay features, should be designed to fully drain within 48 hours of the rain event.

Water ponded in this forebay caused stagnation and conditions amenable for mosquito breeding.

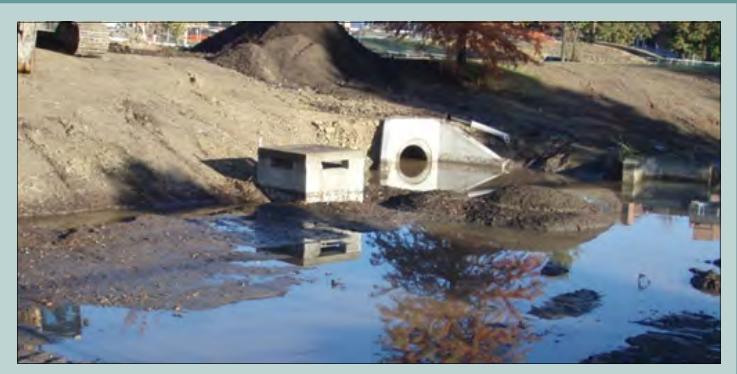
After a rain event, stormwater ponded and sediment built up on top of the bioinfiltration basin's amended soil.

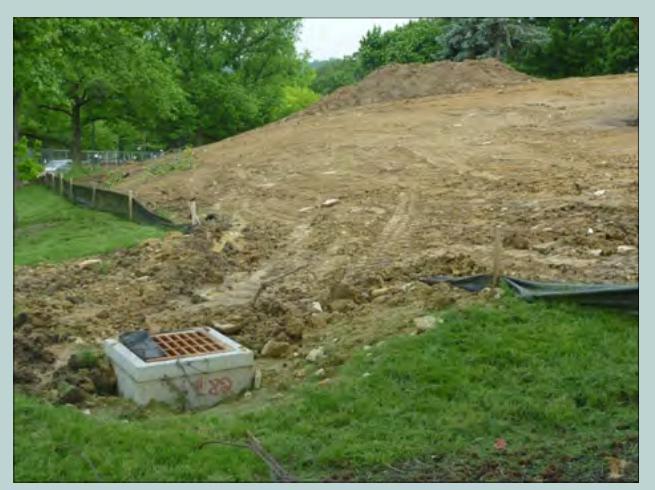
Exposed soil is more susceptible to erosion; and therefore, when vegetation is removed during construction, proper measures for erosion protection and sediment control should be taken. This is particularly important during construction of green features which can be easily clogged if silt and sediment wash into the proposed system.

Broken silt fence promotes erosion and sediment build up in the proposed green feature.

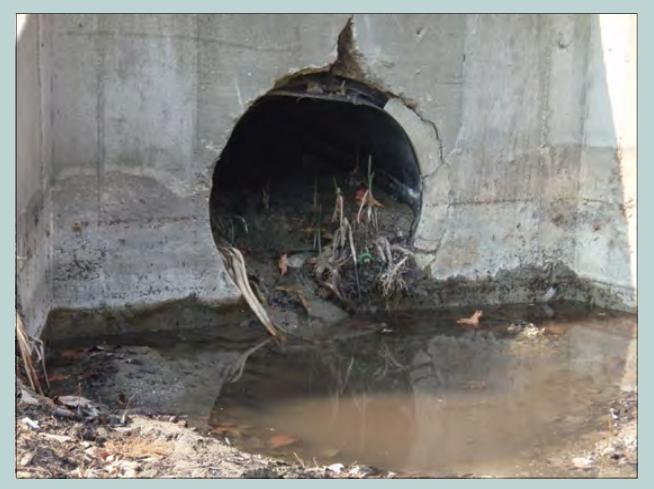
When retrofitting an existing detention basin feature, it is important to understand what drains to existing pipes and the condition of these pipes. In some cases, unknown pipes can bring foreign material into the green feature causing challenges during construction and additional maintenance needs. Here the pipe was jetted before project completion.

Debris and foreign material from an existing pipe draining into a retrofitted detention basin.

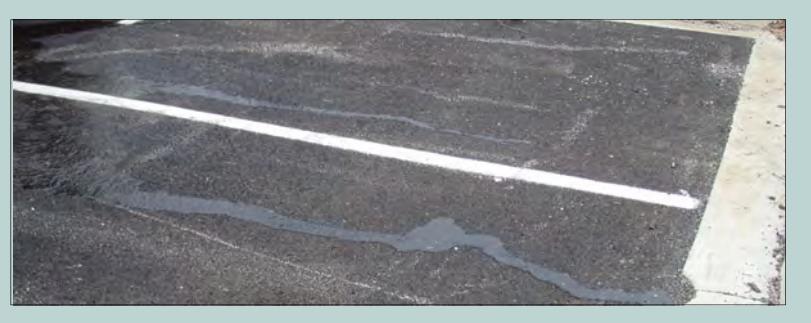
At Cincinnati State, a test was performed by pouring water directly onto dry, porous asphalt pavement and some of the water appeared to runoff across the surface. Porous asphalt must be wetted before water will readily infiltrate into the pavement because the surface tension of dry, porous asphalt does not allow the water to infiltrate until it has been fully wetted.

Water does not infiltrate as readily on dry, porous asphalt.

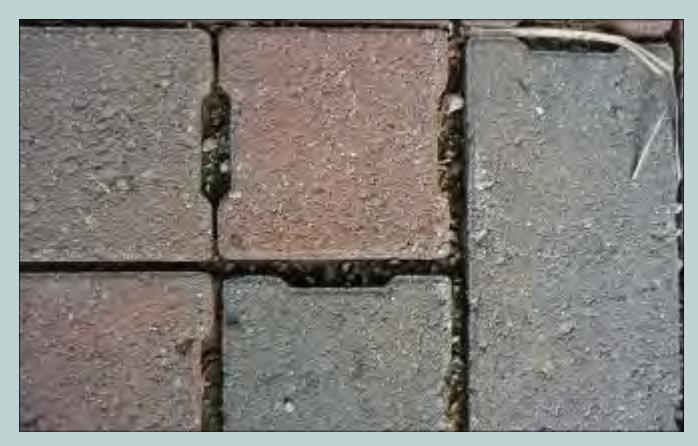
Sediment built up in the porous paver system.

When sloped, mulched planting beds are adjacent to porous pavers, a barrier should be installed on the edge of the mulched planting bed to help prevent the mulch and soil from running off and spreading over the porous pavers. This sediment builds up in the porous paver system and prevents infiltration. The Zoo vacuumed the affected areas to remove accumulated materials. A concrete curb keeps mulch in place in planted area at right.

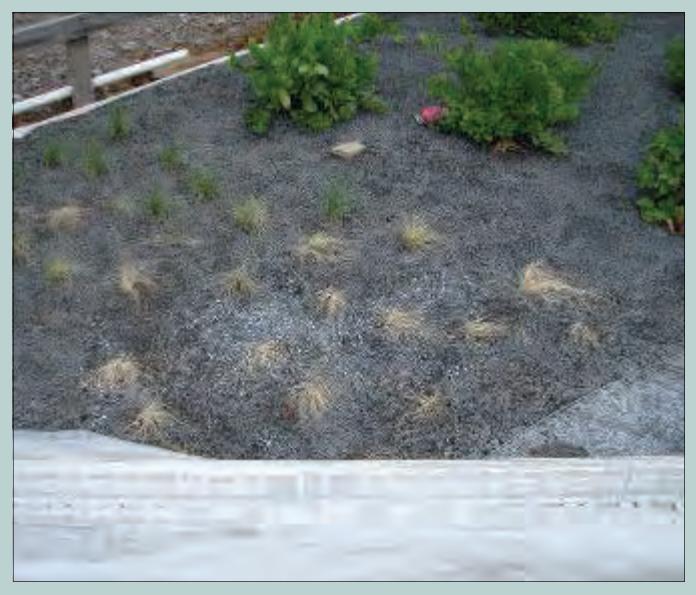
Dead plants on the vegetative roof.

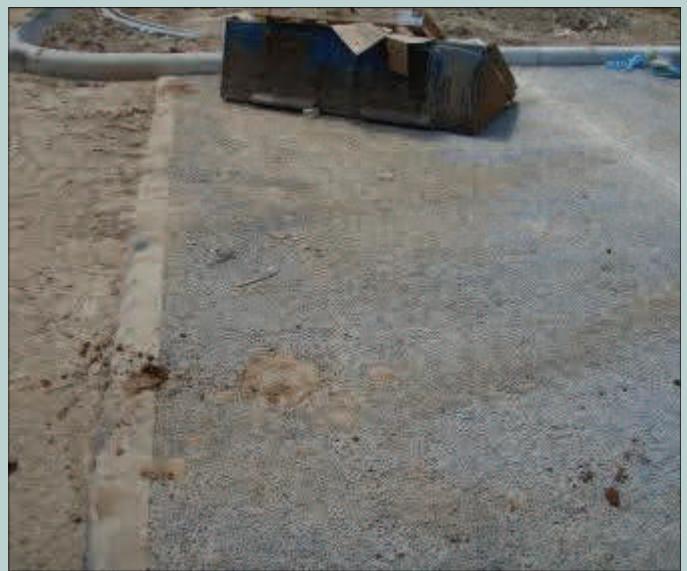
Exposed dirt adjacent to the newly installed porous concrete can cause sediment build up and clog the system.

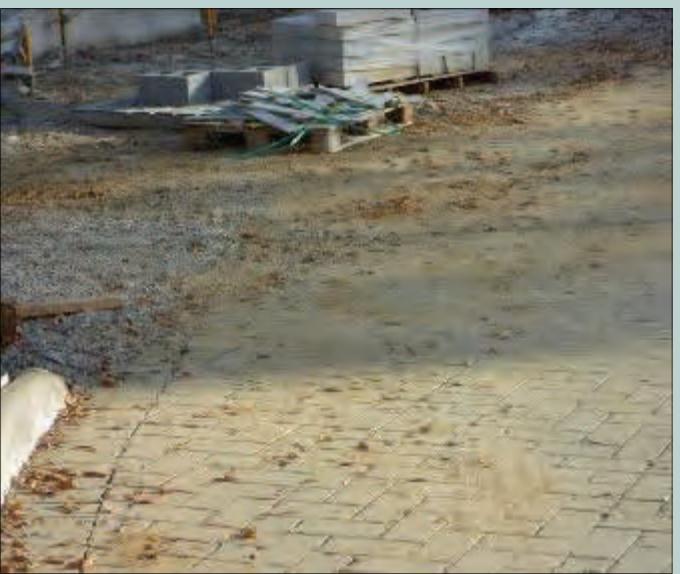
Exposed dirt adjacent to the newly installed porous paver system can cause sediment build up and clog the system.

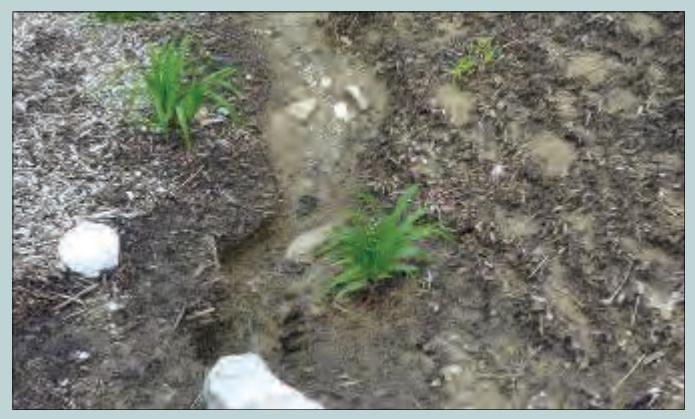
Concentrated flow paths can cause erosive flows and problems with erosion within bioinfiltration green features. Design considerations, such as energy dissipation at the outlet into the feature or minor tweaks to the grading, should have been included in the detailed design of the feature. As this was an early project in the program, energy dissipation was introduced into the design of remaining projects.

Erosion in the bioinfiltration basin.

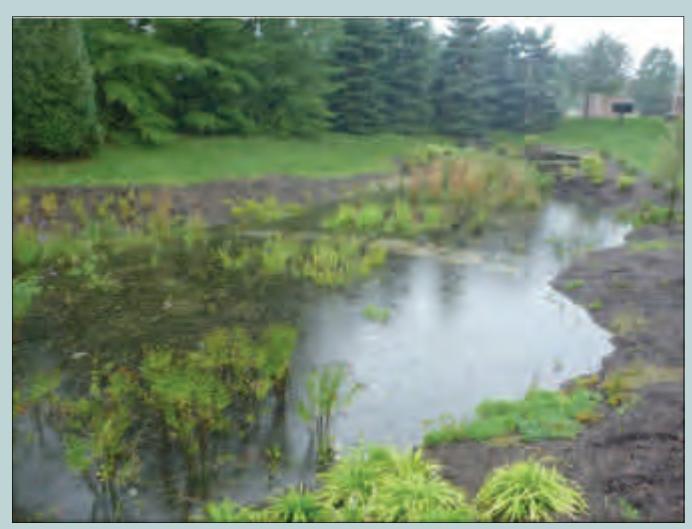
Stormwater ponded in the bioinfiltration basin during a rain event.

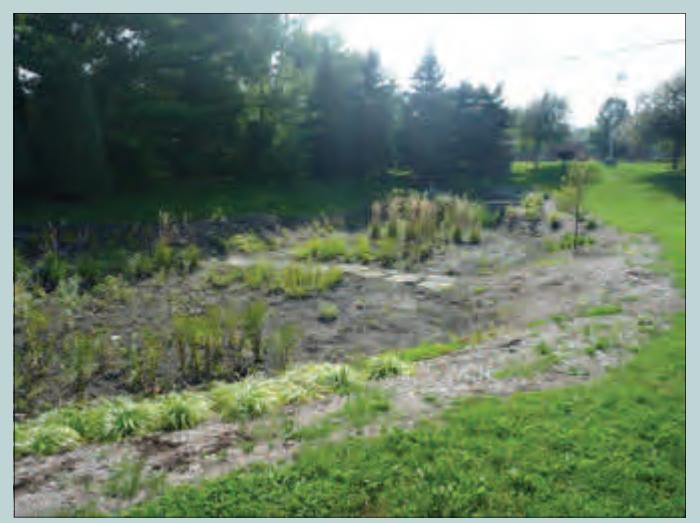
The stormwater has infiltrated through the system 24 hours after the rain event.
