Metropolitan Sewer District of Greater Cincinnati

Enabled Impact Program: Interim Summary Report – November 2013

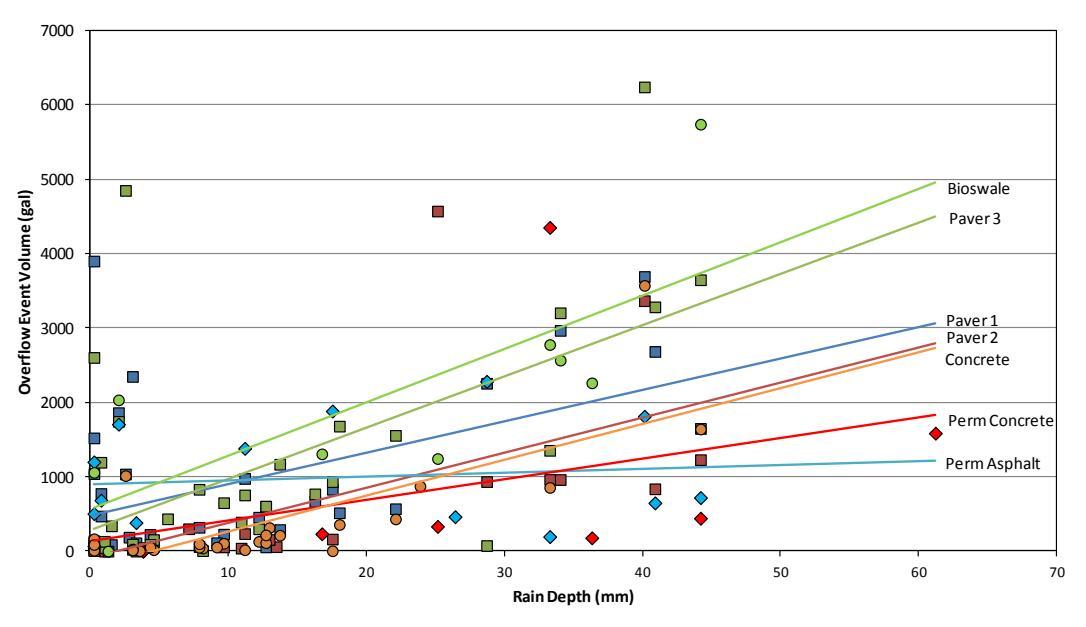
Figure 2: Overflow Volume versus Rain Depth

Once the time series was reduced to only the non-zero values, storm events were identified, tabulated, and plotted for each paver type, as graphed in Figure 2. Plotting overflow volume versus rain depth allows for qualitative comparisons between paver types. The Bioswale data set represents outflow from the Bioswale, which is receiving the overflow from all of the pavement systems. For example, Permeable Asphalt typically produces less overflow volume for a given rain depth than other paver types.

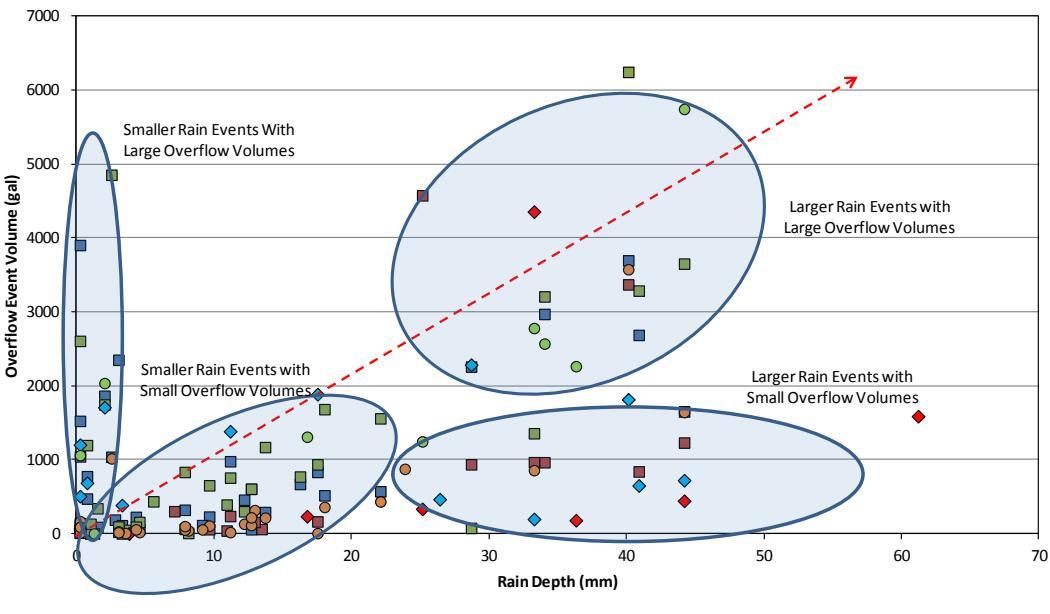
Figure 3: Overflow Volume versus Rain Depth, with similar regions of paver performance grouped together.

Not every paver type produced an overflow event for a given rain event. Rather than focusing on specific data points, similar data points can be grouped into regions which describe general paver behavior. Figure 3 is annotated to include these groups. By looking at which pavement types tend to fall in which groupings, you can learn a bit more about how each one is performing according to the current monitoring infrastructure.

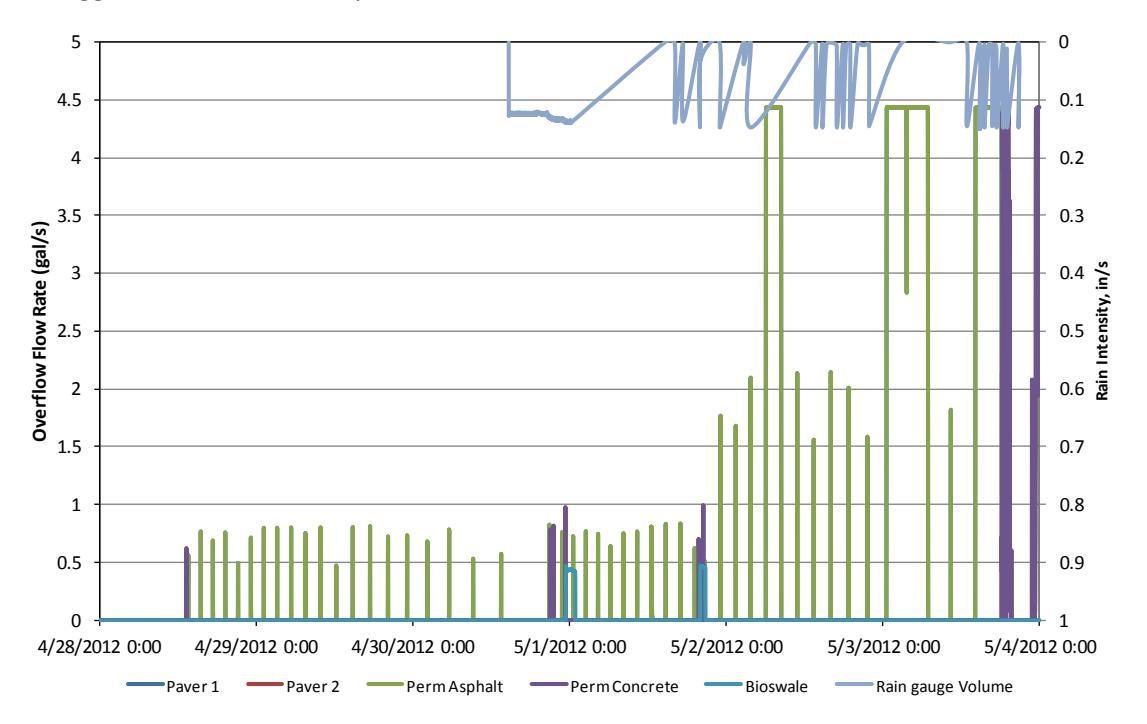
Figure 4: Paver response for example storm event.

overflow. To help correct for these factors, the overflow responses from each pavement were plotted for specific rain events using the provided flow rate data streams. Figure 4 plots the pavement overflow response for an example storm event. The graph appears as individual bars rather than a continuous flow because the data is collected through a pump that purges the water, turns off and then purges again once the water level reaches a certain height.

The flow rate time series of Paver 1 and Permeable Asphalt demonstrate nearly identical responses to each other (making it difficult to see both colors on the graph), as do Paver 2 and Permeable Concrete. Both the Paver 3 and Concrete flow rate time series were missing data during this storm event. The Bioswale triggered an overflow only twice.

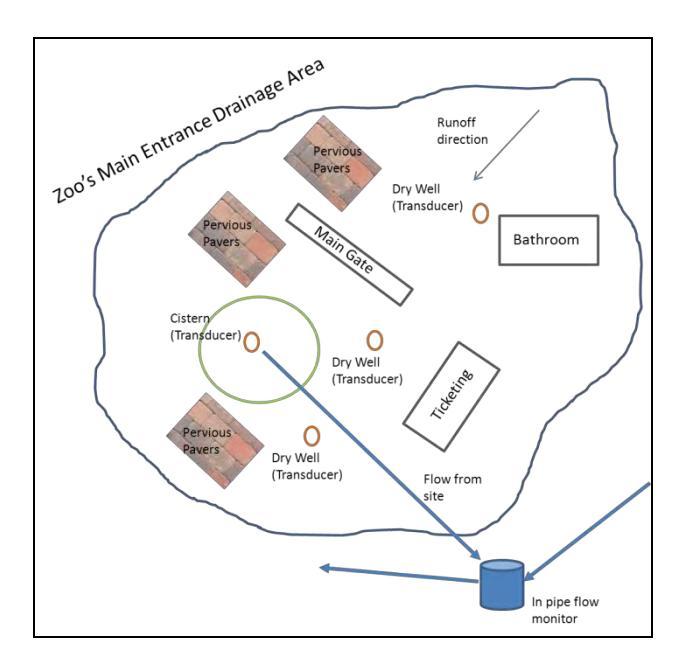
Monitoring at Cincinnati zoo main entrance

Additionally, a robust monitoring plan was not put in place to establish a comprehensive understanding of the entire drainage area at the main entrance. This means that the mass balance from the site could not be achieved because the flow from the pavers goes into a cistern. This cistern does not have a transducer and the zoo is not operating it in an efficient way. Therefore, the analysis for this site could not be completed.

In Q3 2013 transducers were installed correctly at the site based on the schematic below. The in-pipe flow monitor downstream of the cistern will get reinstalled in order to establish the stormwater runoff mass balance for this site to measure the effectiveness of this green infrastructure.

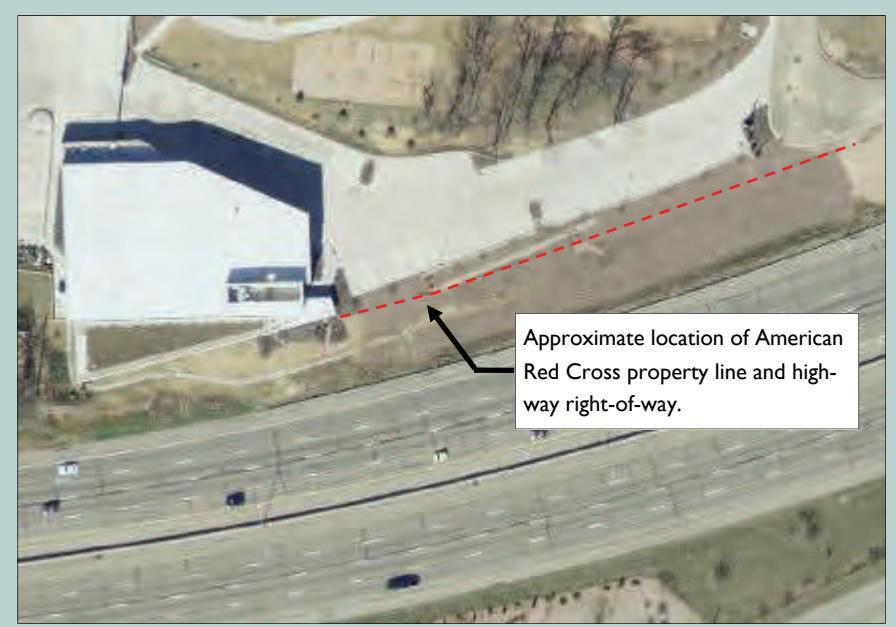
Permitting issues with the state after design completion resulted in major redesign of the bioswale feature. To keep the underdrain, and all other pipes and structures, on the Red Cross property, it was necessary to place the underdrain directly over the slotted drain that discharges water to the feature. The perforated underdrain was constructed as designed, directly below the slotted drain pipe.

While access to this pipe is still available whenever it may be necessary, hydraulically, the water does not always travel the width of the bioswale. In future designs, there should be careful consideration of parcel ownership prior to planning and design completion.

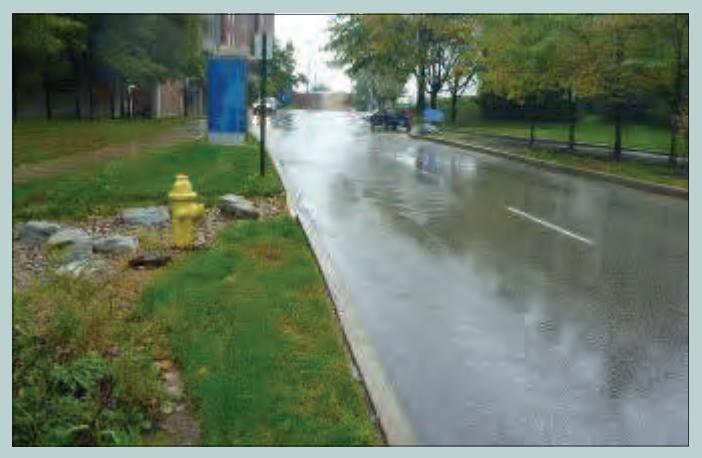
A significant amount of the stormwater runoff from the adjacent roadway bypasses both bioinfiltration basins at Christ Hospital, drains to a downstream inlet, and enters the combined sewer system. Designs should optimize stormwater runoff directed into the facility. Potential solutions include installing curb and gutter with a depression in the pavement to direct stormwater into the facility; placing the bioinfiltration basins further downstream adjacent to the existing inlet into the combined sewer system; or potentially installing a small "bump out" to help direct stormwater into the facility.

Stormwater runoff bypasses the curb cut to the rain garden.

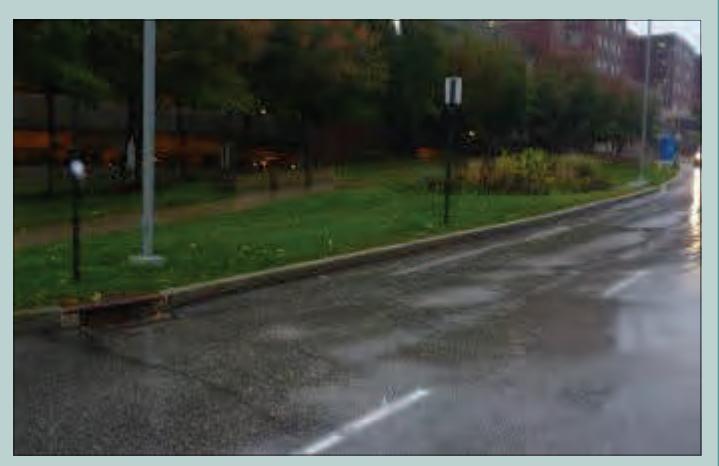
Stormwater runoff enters the combined sewer system.

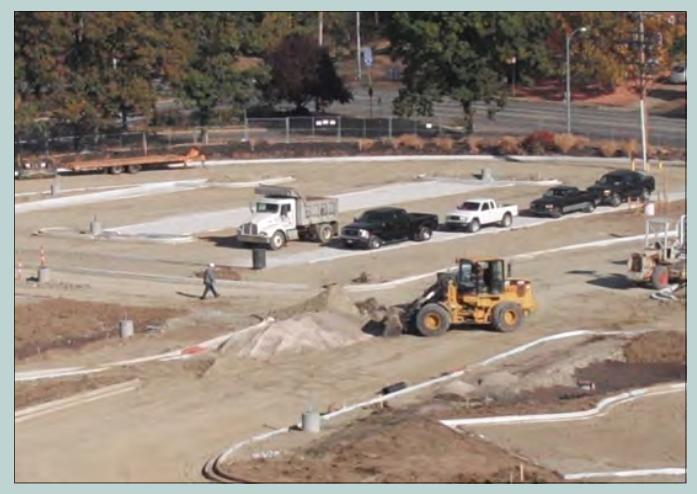
Raw materials were stored adjacent to the proposed porous pavement areas, which allowed unnecessary, excess sediment to build up in the gravel sub base and pavement voids. Additionally, dirty construction equipment was parked on the newly installed porous pavements and excavated material was placed on the newly installed porous pavements. Future projects should not allow raw materials to be stockpiled near any green stormwater management features and should require extra precautions to prevent excess sediment from clogging the green stormwater management features.

Stock piled raw materials adjacent to the porous pavement areas under construction, vehicles parked on features.

Excess silt and sediment on the porous pavement surface can prematurely clog the system.

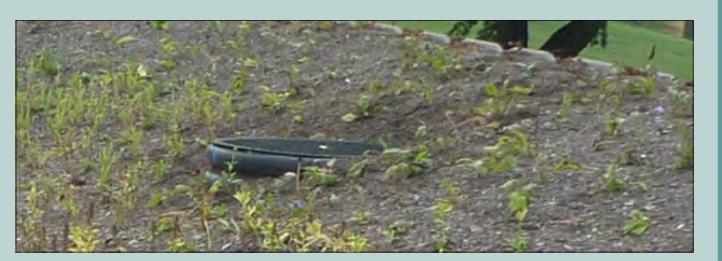
The location and elevation of an outlet control structure should minimize the likelihood of the topsoil and amended soil washing out of the basin and into the sewer system.

Topsoil can easily wash into this outlet control structure.

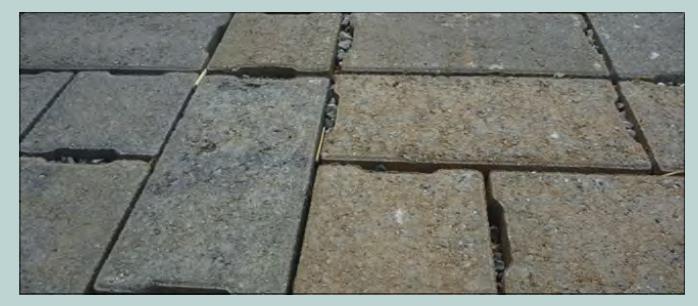
Since the pea gravel fill placed between porous pavers will settle over time, the contractor may need to return after settling to place additional gravel in the paver voids.

The pea gravel in this system has settled.

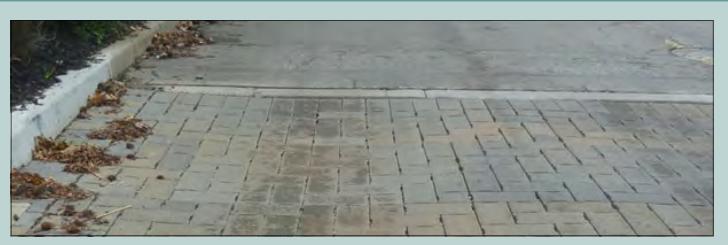
Porous paving located in heavy traffic areas is susceptible to rutting. Some porous pavers have been damaged by heavy trucks. Analysis of the traffic patterns and use of an area should be completed before porous pavement is installed on site. Additionally, paver manufacturers should be consulted about compaction specifications.

Rutted porous pavers from heavy traffic.

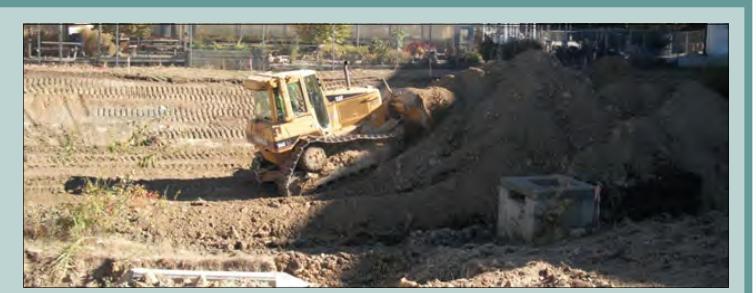
Maximizing infiltration rates of the native soil is crucial to the success of installed green features. When heavy equipment is driven over the surface, the underlying soil is compacted and infiltration capabilities can be significantly reduced. Soil here was scarified prior to installation of the remaining components of the green feature.

Heavy construction equipment compacts the native soil

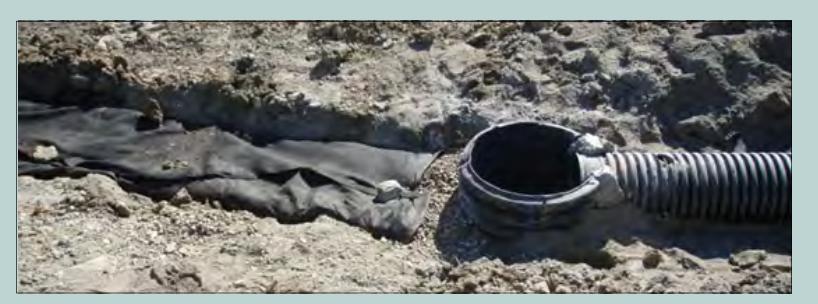
Studies have shown that even a small amount of silt can cause filter fabric around an underdrain to clog. Underdrains should be designed to minimize the probability of clogging. The contractor must take extra precautions to prevent clogging prior to and during installation.

Filter fabric and an underdrain being installed.

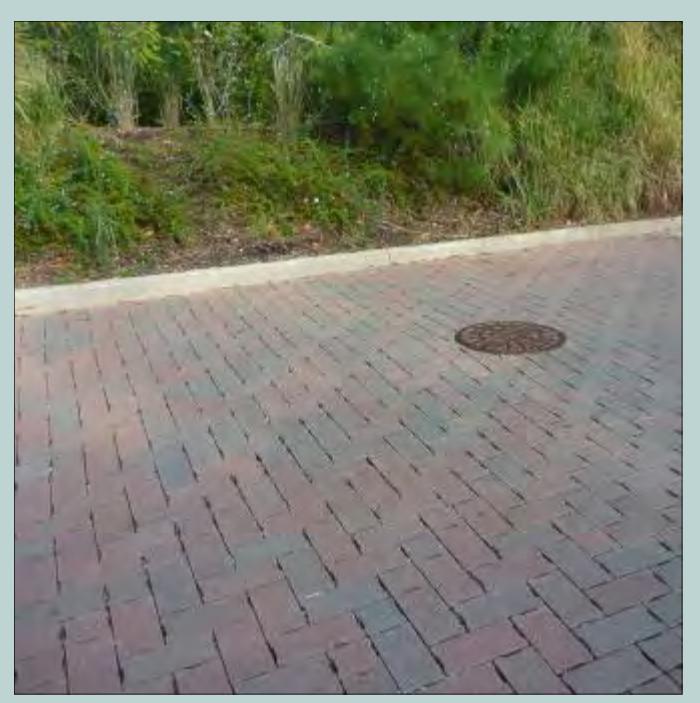
When sloped, mulched planting beds are adjacent to porous pavers, a barrier should be installed on the edge of the mulched planting bed to help prevent the mulch and soil from running off and spreading over the porous pavers. This sediment builds up in the porous paver system and prevents infiltration. The Zoo vacuumed the affected areas to remove accumulated materials. A concrete curb keeps mulch in place in planted area at right.

Sloped, mulched planting bed upstream of porous pavers.

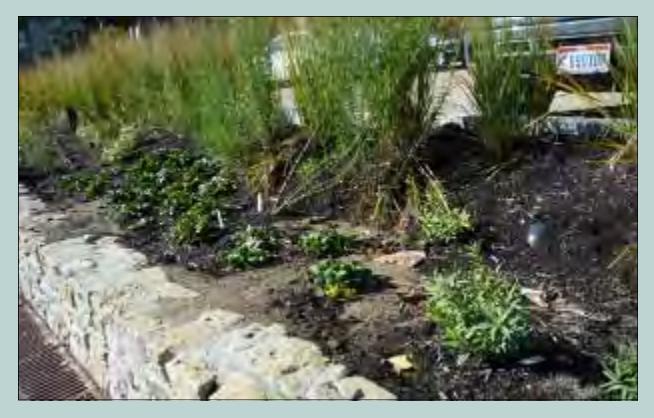
This design includes several green features linked in series to allow stormwater draining from the five porous pavement systems to be pumped directly into a perforated pipe located in the amended soil layer of the bioswales. This was intended to permit saturation of the amended soil to enhance vegetative success in the bioswales. However, sand in the amended soil is blowing of the system above the top soil layers. (See photos) It appears that the system pumps are too strong resulting in the blowouts. Fortunately, flow in the pumps can be regulated. Also, the perforated pipe is to be wrapped in another material to diffuse outward flow strength.

Sand washed out of the amended soil above the topsoil.

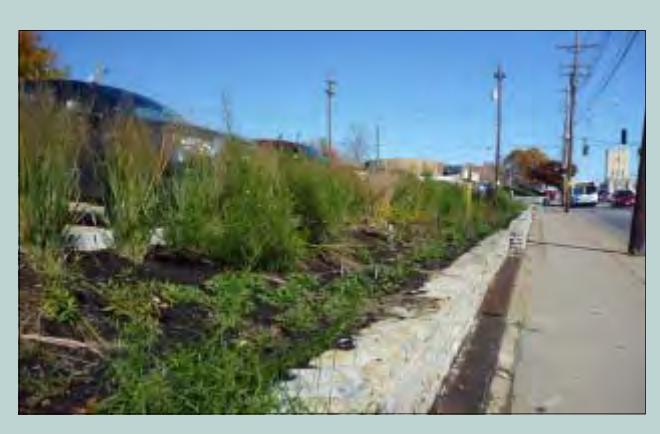
Bioswale overview illustrating sand washout onto adjacent wall.

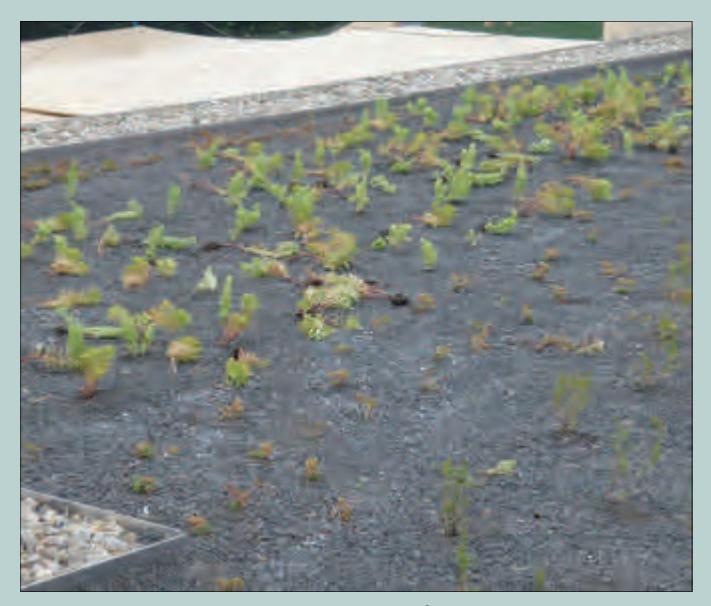
Lesson Learned: Vegetative roofs should be planted after all other roofing is complete.

The intensive and extensive vegetative roofs were planted prior to much of the other work being performed in the vicinity of the vegetative roofs. Construction taking place adjacent to and on the vegetative roofs disturbed—and in some cases killed— the plants on the roofs. Once installed, plants on vegetative roofs should be cared for until they are fully established. In this case, however, care was handed over to the roofing company. The landscape company returned to the site to tend to the plants once construction was finished. All the plants that were disturbed or killed were eventually replaced. Maintenance of the plants is now

Uprooted plants on the vegetative roof.

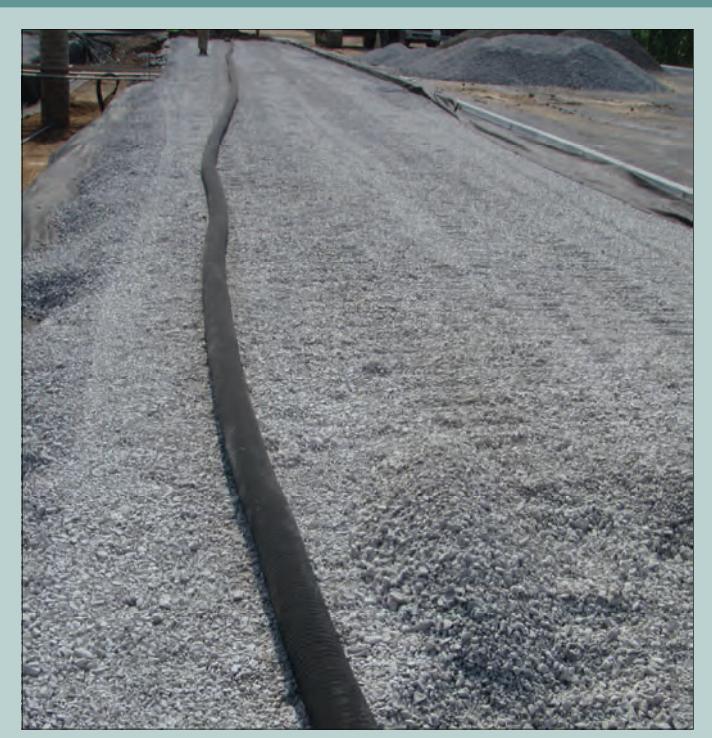
Soil testing was completed on site, but not in the exact location of the proposed green feature locations. During construction, sand seams were found on site, which indicated that infiltration rates may be high, and therefore, underdrains may not be necessary. This finding was not brought to the attention of the design engineer or landscape architect on the project until much of the construction had occurred. At that point, one underdrain had already been installed, and all the underdrains for the site had been ordered. Although no additional soil testing was completed, the decision was made to plug the underdrain that was already installed and to install all other green features on site without underdrains. In some cases the engineered soil had also been placed. The soil contained sand, as per the design. The sand would make the feature drain too rapidly—so the engineered soil was removed and replaced with a non-sand soil mixture. This additional effort and cost may not have been necessary.

Underdrain to be installed in the bioswale.

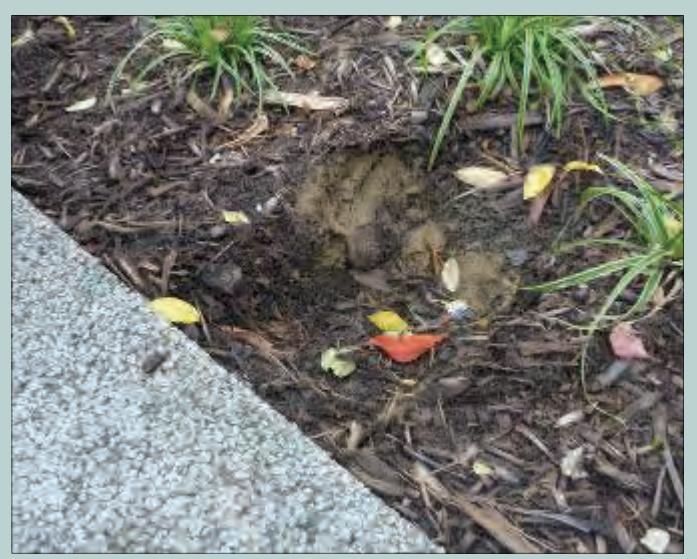
Parking blocks were not included in the design of this parking lot bioswale. Students and staff using the lot have accidentally driven their cars over the edge of the parking stalls, getting stuck in the bioswale and causing ruts in the amended soil. Parking blocks were placed prior to opening the parking lot to the general public. Bollards are to be installed at either end of the bioswale.

Tire ruts in the soil.

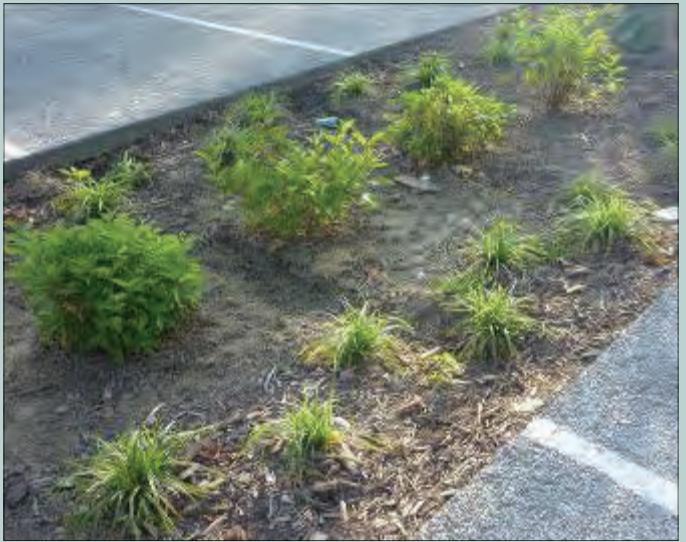
Tire ruts in the soil.

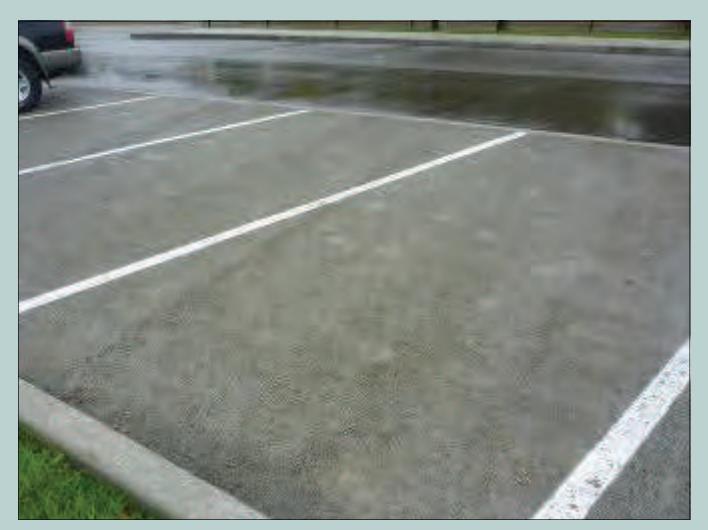
Despite geotechnical test results indicating the presence of sandy soils with high infiltration rates (greater than 6 inches per hour), only a small portion of the project site was designed to drain toward a green feature, pervious concrete parking stalls. In cases with soils favorable for stormwater infiltration, additional green infrastructure features should be encouraged to maximize the stormwater volume reduction benefit in these locations.

Porous concrete at Hartwell Elementary.

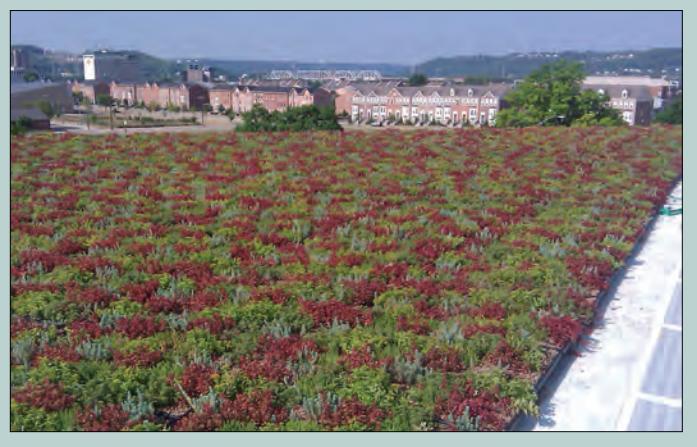
Structural analyses are required to determine how the loading of a green roof can impact an existing or proposed structure. In this circumstance, additional steel was needed to support the loading of the green roof, which adds to the cost of the feature. Vegetative roofs may ultimately be more feasible on existing structures with adequate structural stability to support a green roof.

Extensive vegetative roof at Taft IT High School.

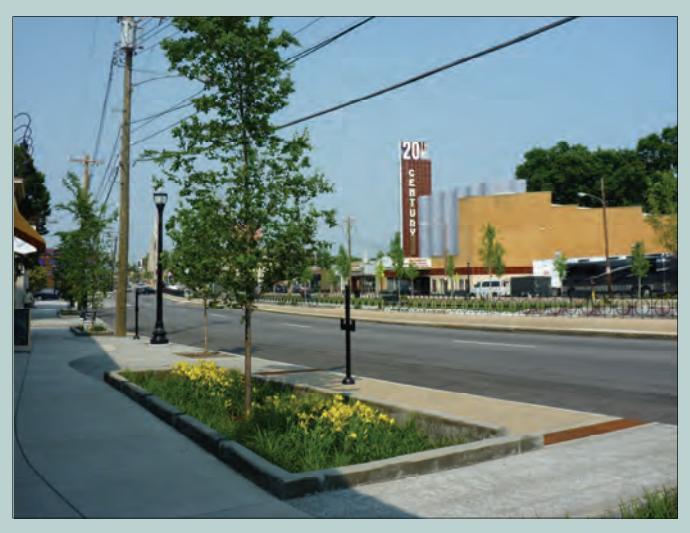
Bioretention planters in an urban setting can become costly, particularly within a sidewalk area that requires perimeter curbing or walls. The concrete required for this can add significant expense, and the construction required for the walls can become cumbersome for a smaller bioretention planter box. Other cost effective alternatives could be considered on similar projects to lower the overall project costs.

Bioretention planter box.

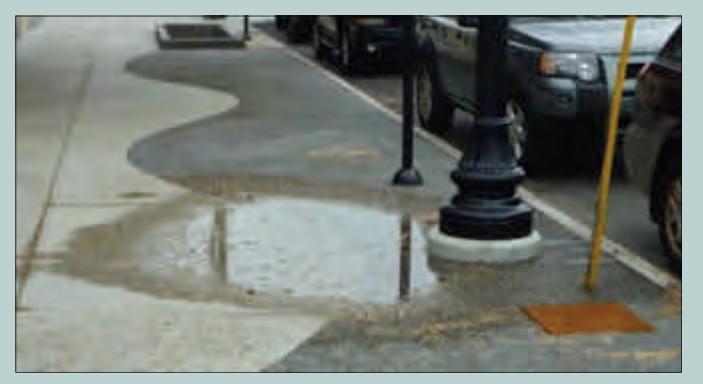
Long-term maintenance of green features is important, and may become more difficult when multiple businesses are involved in a project. Although one entity plans to maintain these features, oversight may be needed to verify the features are being maintained properly. For example, a small area of porous concrete sidewalk shows signs of ponding water during heavy rain events, and should be cleaned.

Stormwater ponded on the porous concrete sidewalk.

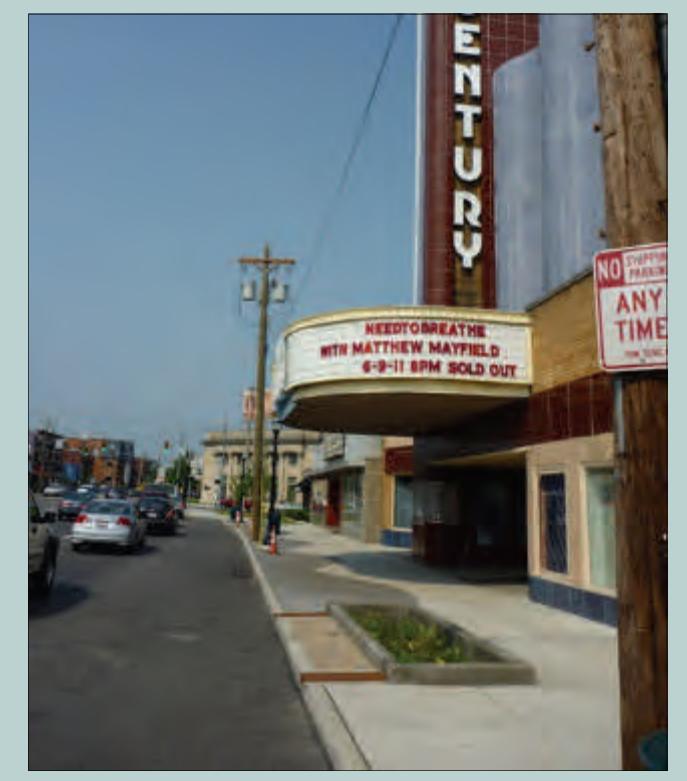
When designing green features, consider placement and visibility so pedestrians are aware of the feature. Although curbing and plants typically provide a clear distinction of a bioretention planter, other items to consider include small perimeter fencing, larger bushes, trees, or additional lighting. Installing some vegetation on both sides of the curbing to provide a buffer between the sidewalk and the depressed bioretention planter could be beneficial as well.

Stormwater planter located outside entrance/exit to theater.

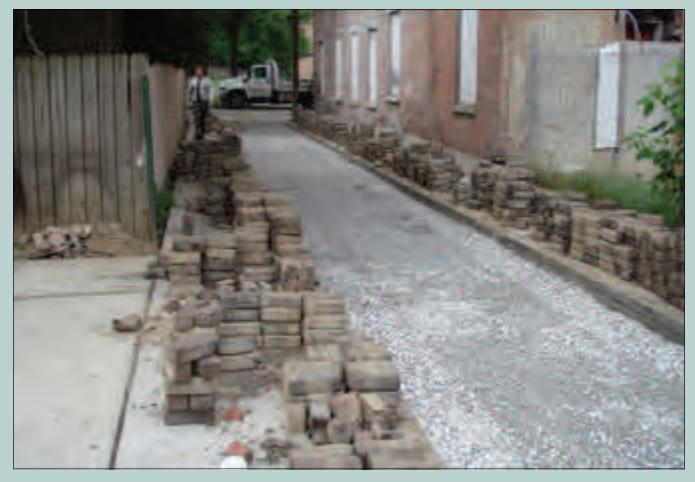
Provided the design includes a gravel sub base, the pavers are washed appropriately and proper spacing is applied to allow for infiltration, existing traditional pavers can be reused as permeable pavers.

Existing pavers prepared to be reused as a porous pavement system.

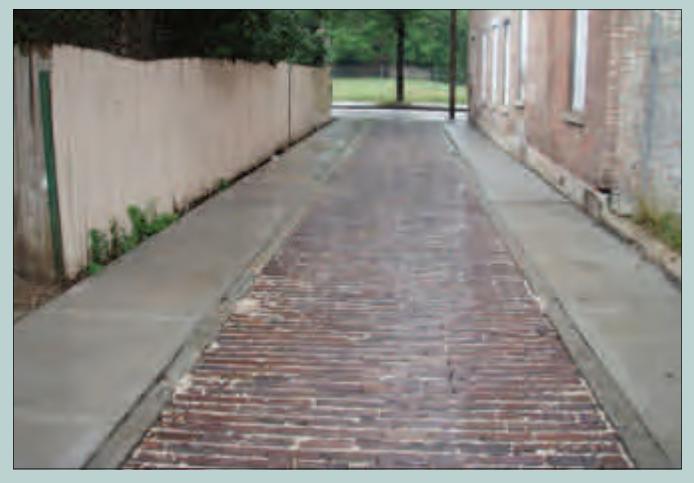
Newly installed porous paver alley.
